Manhole Inspection Summary

Manhole # S15WW_011MH

Insp Date: **12/18/08 3:34 PM**

Location Address: **3312 REISTERSTOWN RD [BP STATION]**

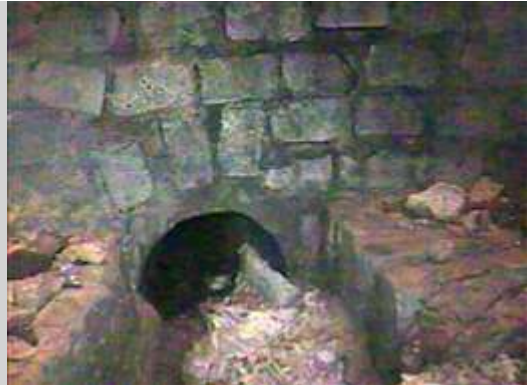
12 O'Clock Outflow

8 in. Circular Gravity Sewer
Pipe Out @ 12 O'Clock

Pipe Height: (in.) Direct
Pipe Material: **Clay** ☐ Pipe Lined
Invert Depth: **9.55** (ft.) Flow Characteristics: **Slow**
Deposits: ☐ None ☐ Mud ☒ **Sludge** ☒ **Debris** ☐ Grease
Silt Depth: **1.5** (in.) Deposits Extent: **Light**
Infiltration: **None** Pipe Seal Cond: **Sound**

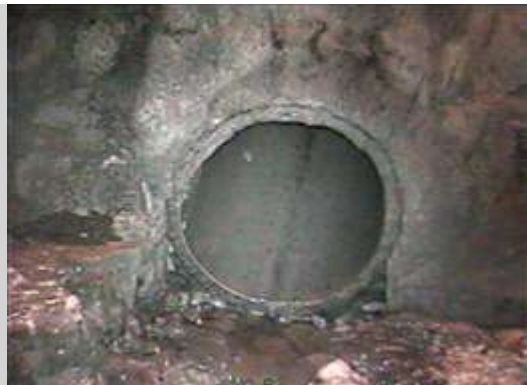
4 O'Clock Inflow

6 in. Circular Gravity Sewer
Pipe In @ 4 O'Clock

Pipe Height: (in.) Direct
Pipe Material: **Clay** ☐ Pipe Lined
Invert Depth: **9.45** (ft.) Flow Characteristics: **Slow**
Deposits: ☒ None ☐ Mud ☐ **Sludge** ☐ Debris ☐ Grease
Silt Depth: (in.) Deposits Extent:
Infiltration: **None** Pipe Seal Cond: **Sound**

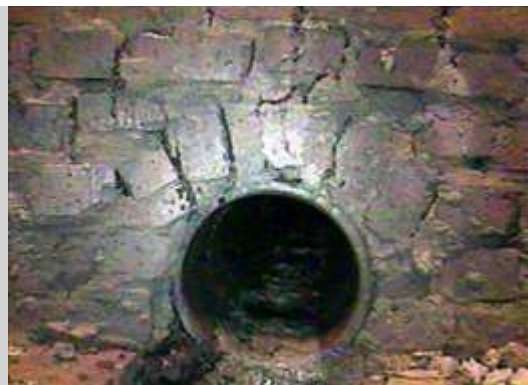
7 O'Clock Inflow

8 in. Circular Gravity Sewer

Pipe In @ 7 O'Clock

Deposits: ☐ None ☐ Mud ☒ **Sludge** ☐ Debris ☐ Grease

Silt Depth: **0.5** (in.) Deposits Extent: **Light**
